HIGH SPEED CORRODER PRETEST XXXXX Half-moon Outdoor lamp.

Product description from the manufacturer: Half-moon outdoor lamp in galvanized Steel.

This report contains the data and results for a tested XXXXX Outdoor lamp, model YYYYY, sold with 15 years’ warranty in most DIY centers. The subject was exposed to HACT for 10 days in the HSC 512 chamber.

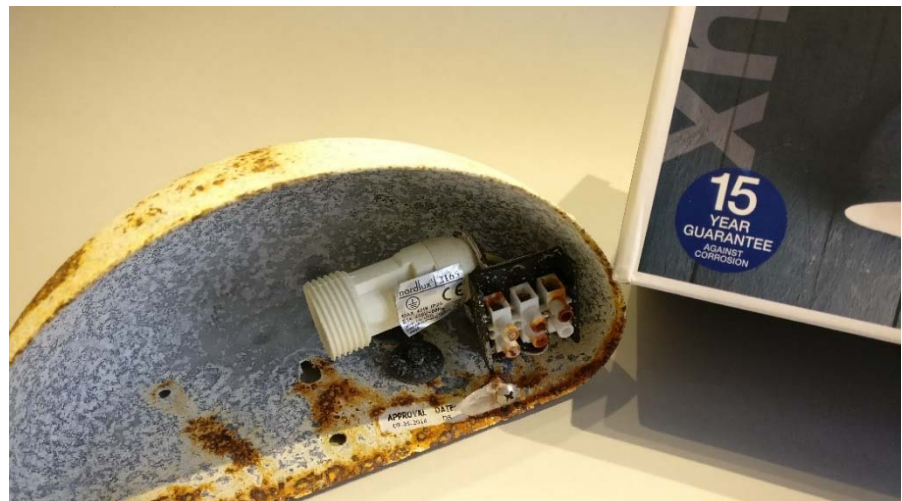
Short conclusion: After 10 days' exposure to "Highly Accelerated Corrosion Testing" (HACT), the galvanized surface shows significant corrosion. The electrical terminal is damaged to an extent where it is no longer possible to unscrew the screws. The mate protection plastic, covering the bulb broke of as a result of expanding screws.

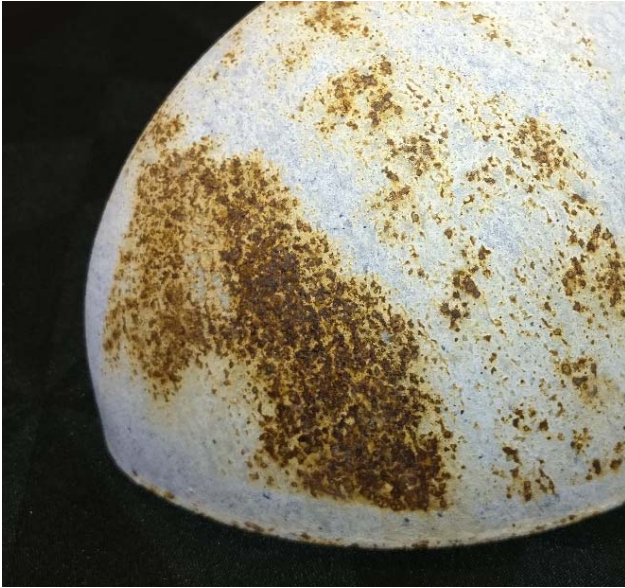
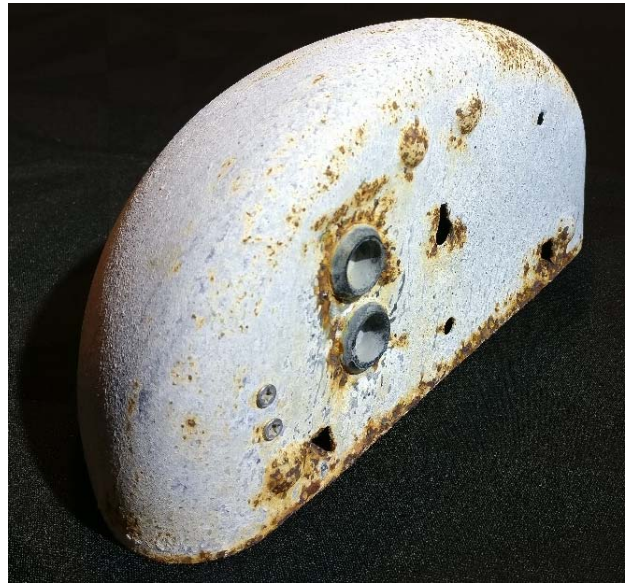
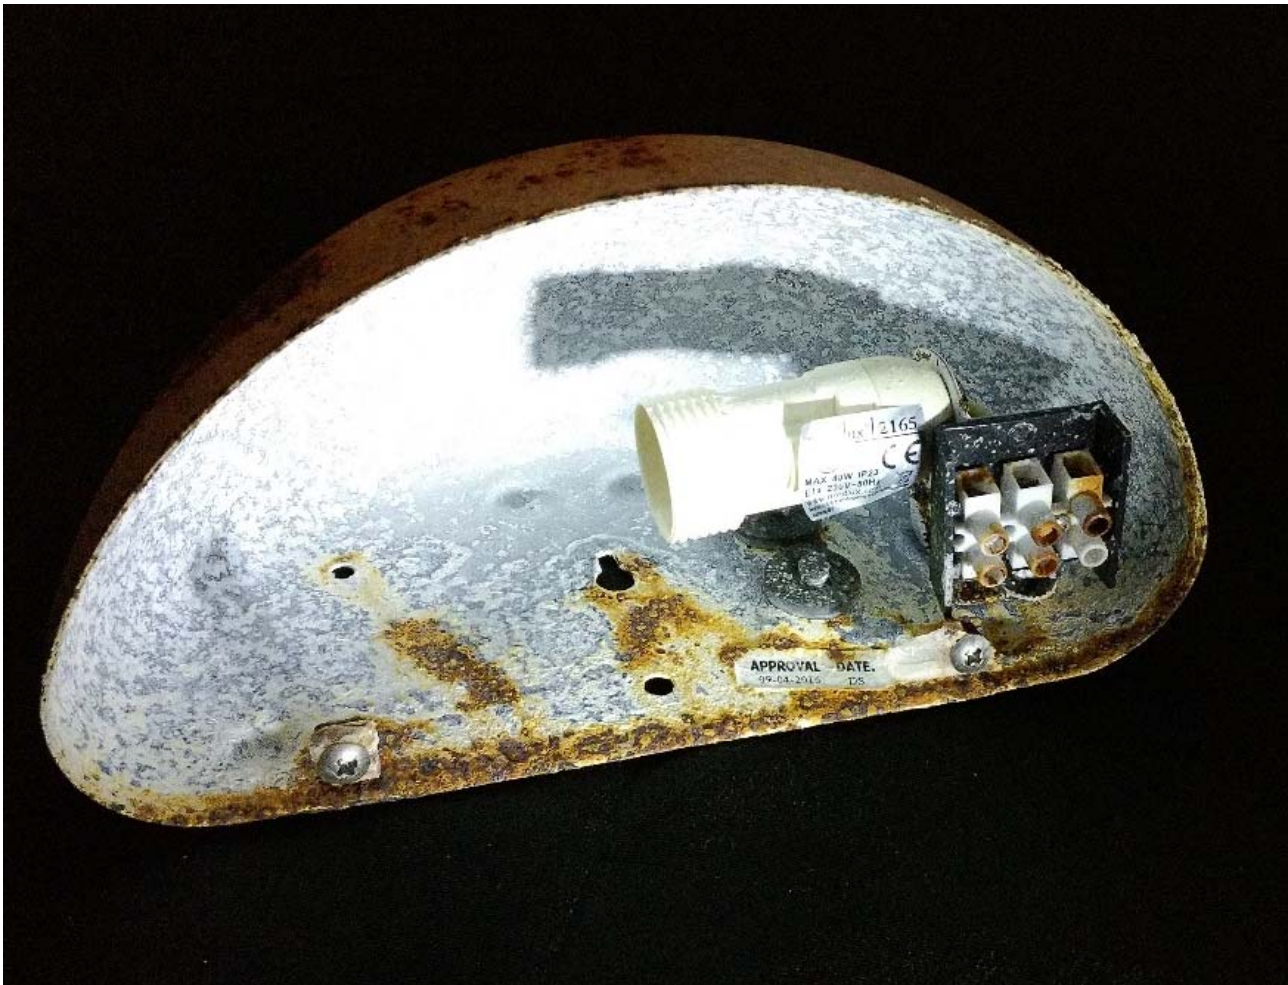
After 10 days’ exposure to a "Highly Accelerated Corrosion Test", the Galvanized surface shows significant corrosion and rust. The electrical terminal is damaged to an extend where it is no longer possible to undo the screws. The mate protection plastic, covering the bulb, broke of due to the screws holding the plastic became bloated from a substantial amount of red rust and thereby the screws expanded in size.

Detailed photos of the damage created by the HACT process:
