HIGH SPEED CORRODER PRETEST

XXXXX YYYYYY lightweight steel roofing tiles.

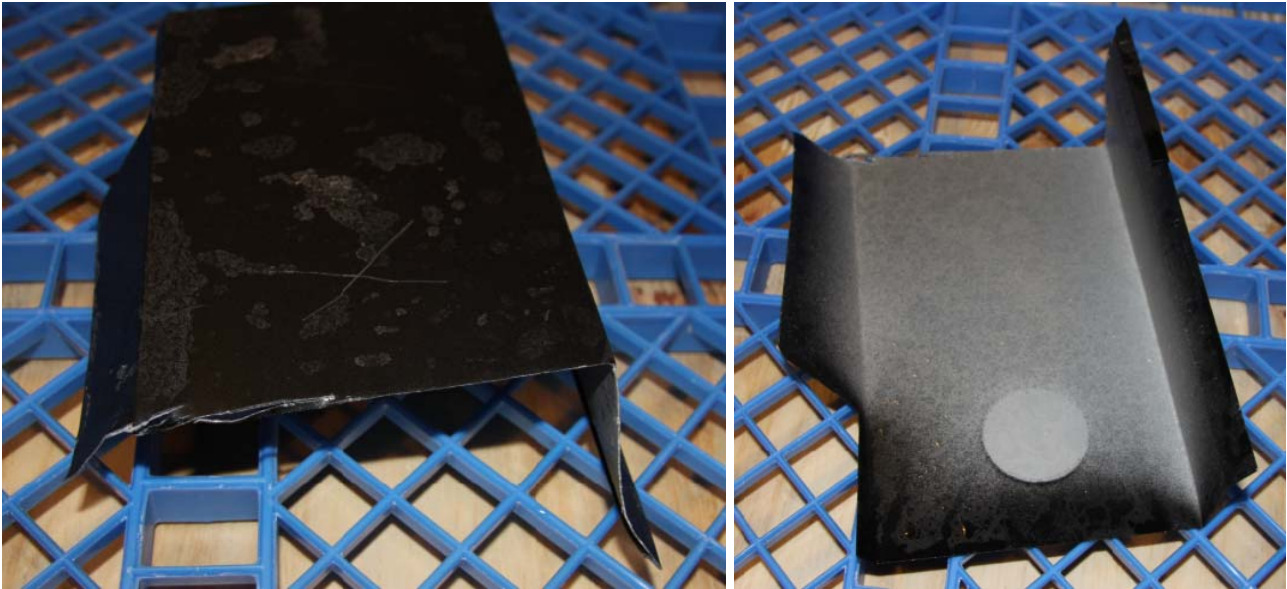
The XXXXX steel roofing tiles has had a 7 days' test before this test. The metal roof is showing signs of corrosion and it is assumed to be white Zinc oxides from an electro galvanization of the metal plates. Image showing the metal plate after 4 days of pre-exposure 3 days before this test begun.

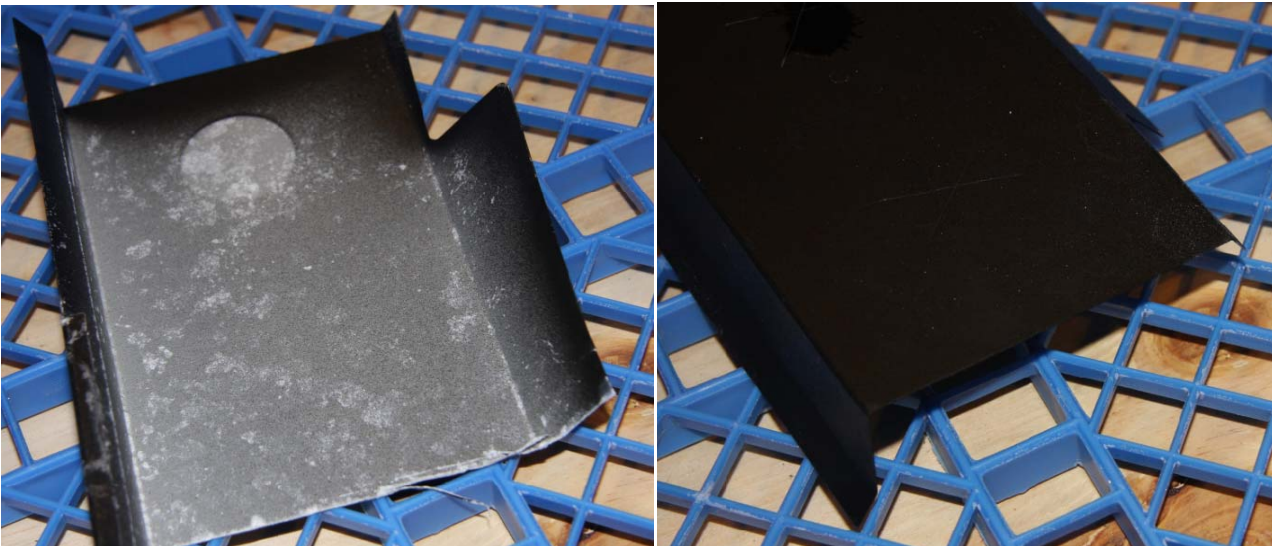
After 7 days of pre-exposure the inside coating is also showing signs of corrosion, metal oxides penetrating the coating is assumed to be Zinc oxides, there is no visible red Iron oxides present.

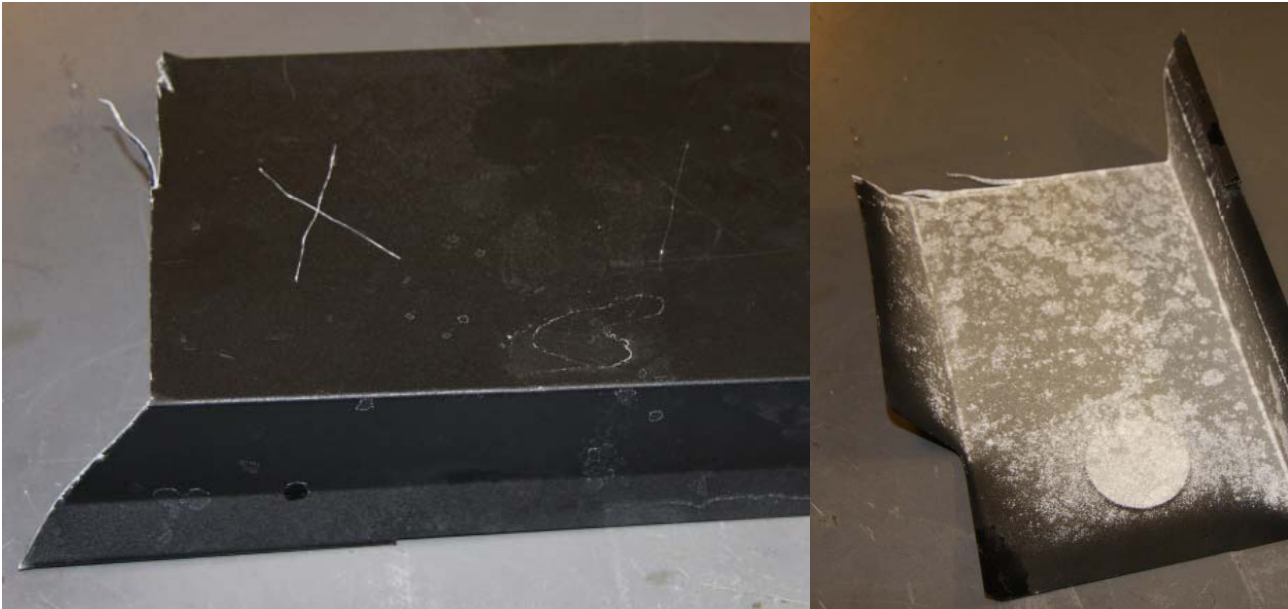
After 10 days of total exposure the metal roof is clearly showing degradation from the assumed Zinc oxides, the x scratch on the top of the plate is visible and the inside coating is showing an almost uniform degradation.

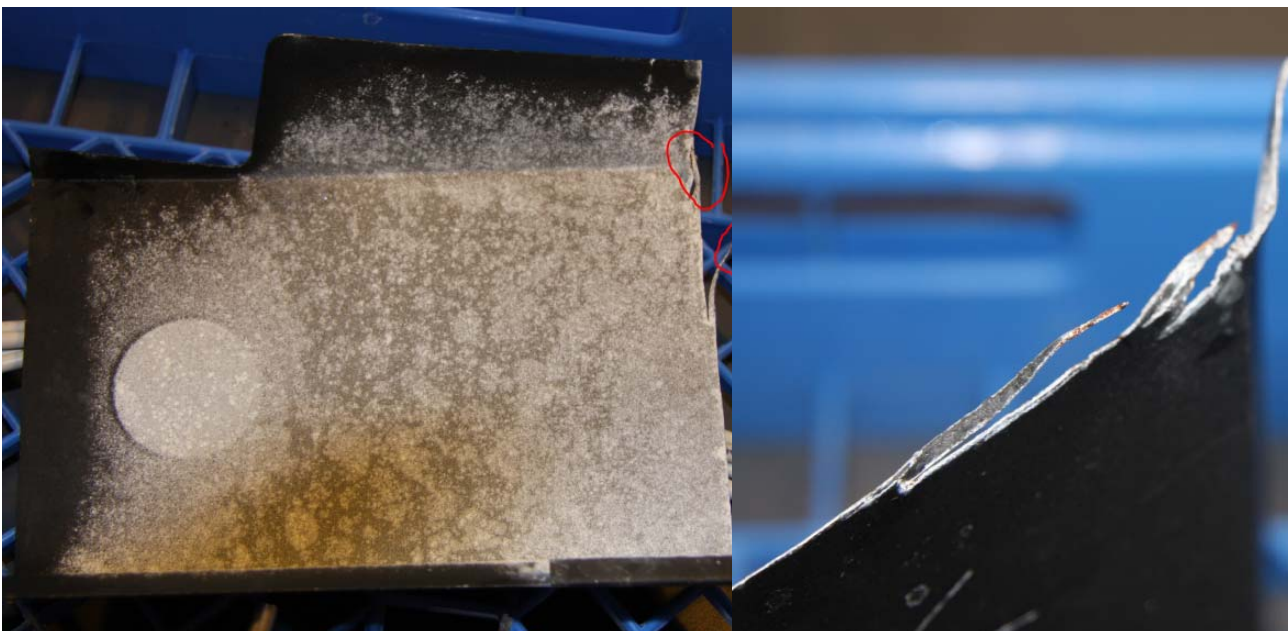
After 14 days of total exposure the metal roof plate is showing more degradation and now assumed red Iron oxides is present at the cutting edges and inner surfaces (red arrows).

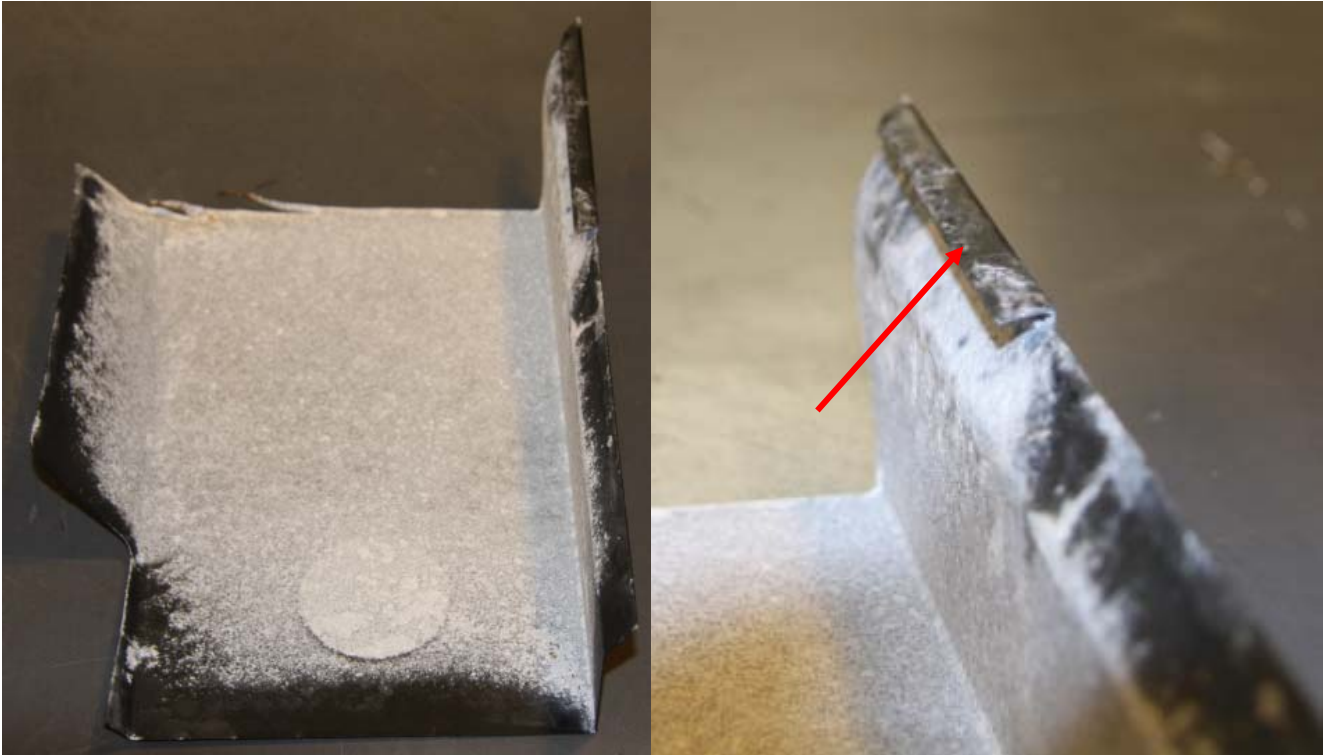
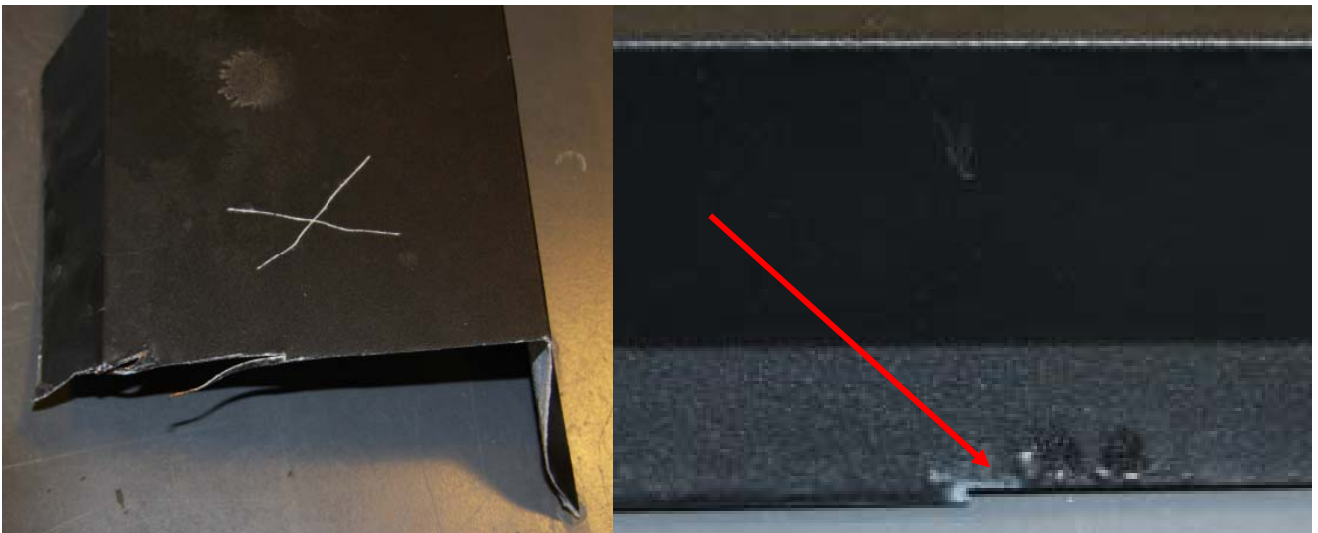
After 18 days' exposure to a "Highly Accelerated Corrosion Test", the metal roof plate is heavily attacked by the assumed Zinc oxides and also some Iron oxides. The coating is also showing corrosion bubbles indicating the degradation is taking place under the coating. There is a greater concentration of the white oxides at the edge bend of the metal plate and the bubbles is largest at the bend area.

After 18 days of total exposure, the metal roof plate is now heavily attacked by the assumed Zinc oxides and also some Iron oxides. The coating is also showing corrosion bubbles indicating the degradation is taking place under the coating (red arrows). There is a greater concentration of the white oxides at the edge bend of the metal plate and the bubbles is largest at the bend area.
