HIGH SPEED CORRODER PRETEST XXXXX Half-moon Outdoor lamp.

Product description from the manufacturer: Half-moon outdoor lamp in galvanized Steel.

This report contains the data and results for a tested XXXXX Outdoor lamp, model YYYYY, sold with 15 years’ warranty in most DIY centers. The subject was exposed to HACT for 10 days in the HSC 512 chamber.

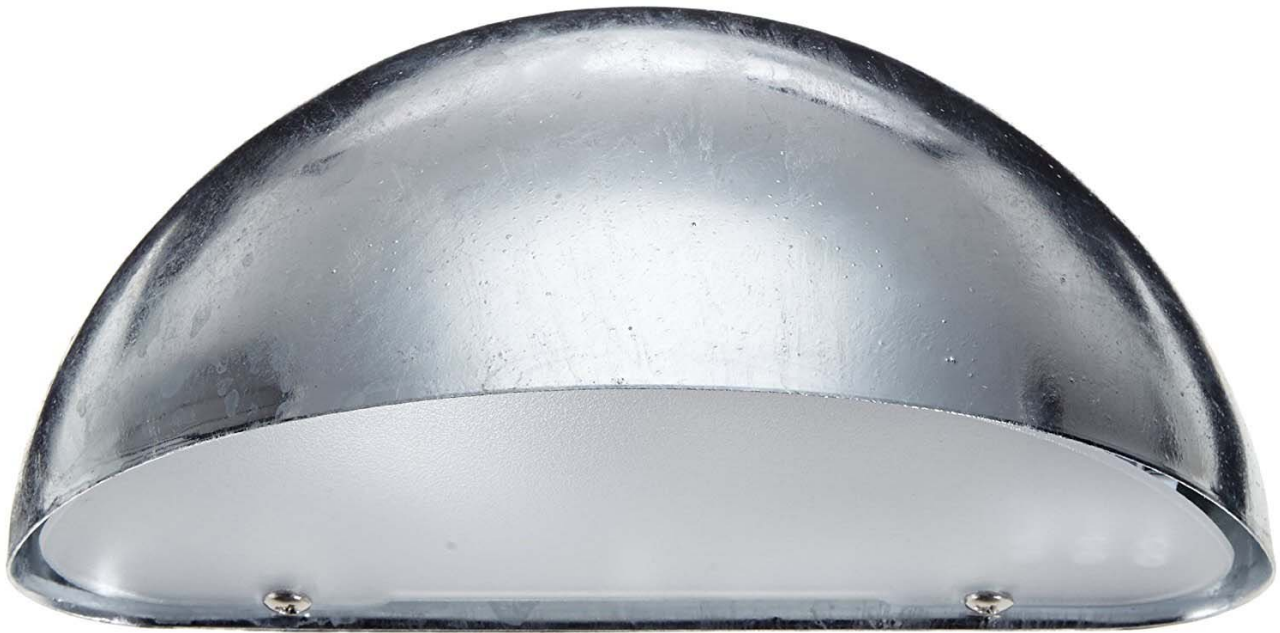
Short conclusion: After 10 days' exposure to "Highly Accelerated Corrosion Testing" (HACT), the galvanized surface shows significant corrosion. The electrical terminal is damaged to an extent where it is no longer possible to unscrew the screws. The mate protection plastic, covering the bulb broke of as a result of expanding screws.
